Manhole Inspection Summary

Manhole # S71K__005MH

Insp Date: **5/16/08 11:00 AM**

Location Address: **6739 Graceland Ave.**

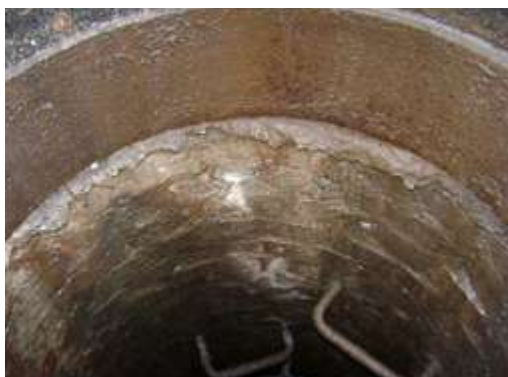
Defect 1

Condition: ☐ Sound ☐ Cracked ☐ Root Intrusion ☒ **Loose Brick** ☐ Deteriorated

Infiltration: ☐ None ☒ **Joint** ☐ Cracks ☒ **Mortar** ☐ Roots ☐ Wall

Infiltration in chimney

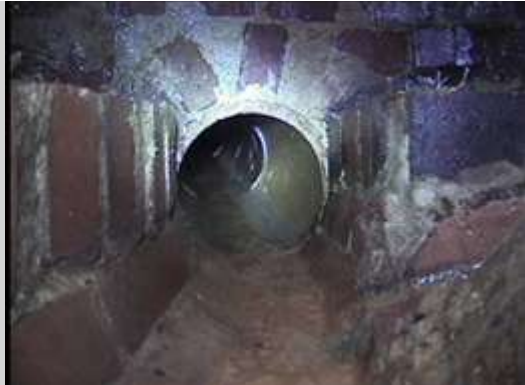
12 O'Clock Outflow

8 in. Circular Gravity Sewer
Pipe Out @ 12 O'Clock

Pipe Height: **8.4** (in.) Rod and Bar (Angled)
Pipe Material: **Clay** ☐ Pipe Lined
Invert Depth: **8.75** (ft.) Flow Characteristics: **Slow**
Deposits: ☒ None ☐ Mud ☐ Sludge ☐ Debris ☐ Grease
Silt Depth: (in.) Deposits Extent:
Infiltration: **None** Pipe Seal Cond: **Sound**

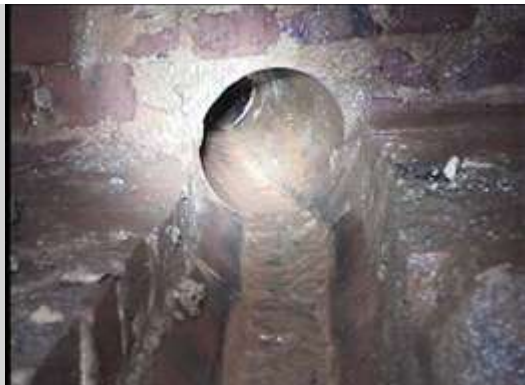
3 O'Clock Inflow

6 in. Circular Gravity Sewer
Pipe In @ 3 O'Clock

Pipe Height: **6** (in.) Rod and Bar (Angled)
Pipe Material: **Clay** ☐ Pipe Lined
Invert Depth: **8.17** (ft.) Flow Characteristics: **Slow**
Deposits: ☒ None ☐ Mud ☐ Sludge ☐ Debris ☐ Grease
Silt Depth: (in.) Deposits Extent:
Infiltration: **None** Pipe Seal Cond: **Sound**

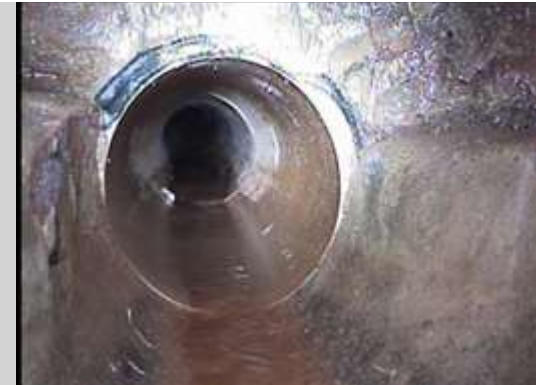
6 O'Clock Inflow

8 in. Circular Gravity Sewer

Pipe In @ 6 O'Clock

Infiltration: **None** Pipe Seal Cond: **Sound**

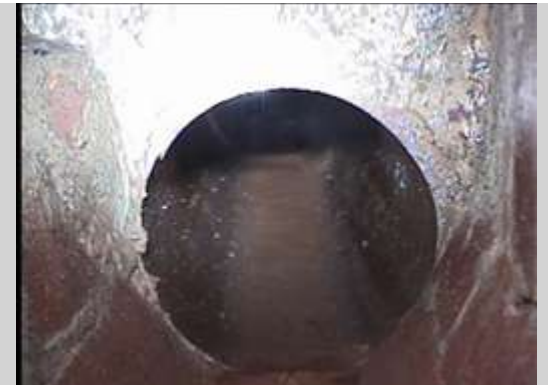
8 O'Clock Inflow

6 in. Circular Gravity Sewer

Pipe In @ 8 O'Clock

Infiltration: **None** Pipe Seal Cond: **Sound**
